NAVISTAR, INC

DEFECT INFORMATION REPORT

REPORT ID: 15-All-Engines-12000814-01
Revision:-
Ref. Investigation:-
Ref. AFC:-
Ref. VER:-

DATE : December 22, 2015

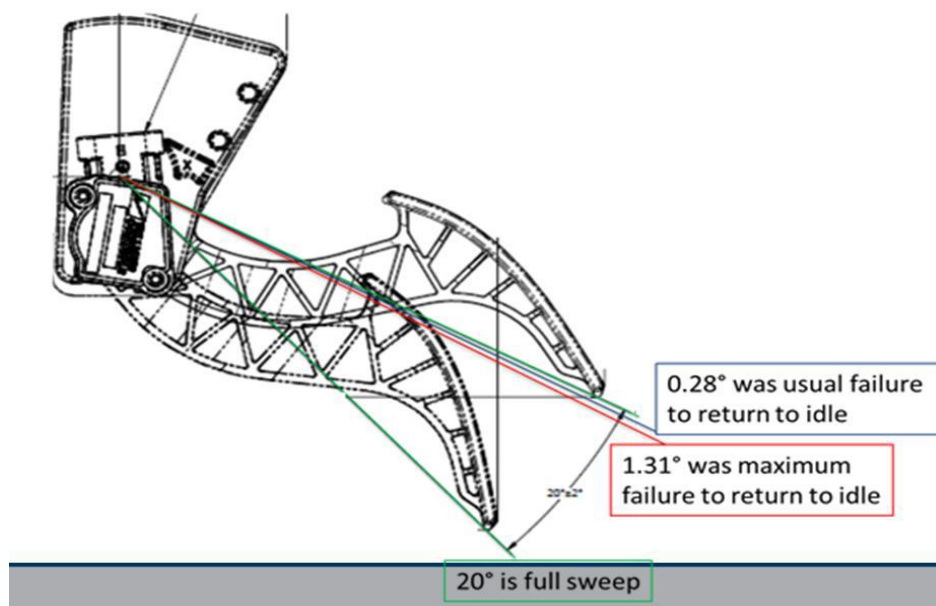
This report addresses a defect concerning the vehicle Accelerator Pedal. Certain Navistar vehicles have a risk of increased idle speed. Due to manufacturing process errors, the accelerator pedal sensor stator may move slightly on the mounting bracket. This movement will change the sensor signal output resulting in an increased idle engine speed condition. Certain engine families are OBD certified and certain monitors require low engine idle speeds as entry conditions for operation, therefore these monitors will not operate.

Any vehicle that experiences this failure will likely be immediately serviced. Navistar has identified two remedies. One is pedal replacement, the other is installation of an ECU calibration with an increased “dead-band” where a small stator offset will not command an increased engine speed. The calibration will be applied to engine families containing large populations of affected engines, a new pedal to those with low populations.
